ALN Th@3 - February 3, 2022

Richard C. Culbertson

Pittsburgh's Frick Park's Fern Hollow Bridge
Collapse On January 28, 2022,
A Preliminary View

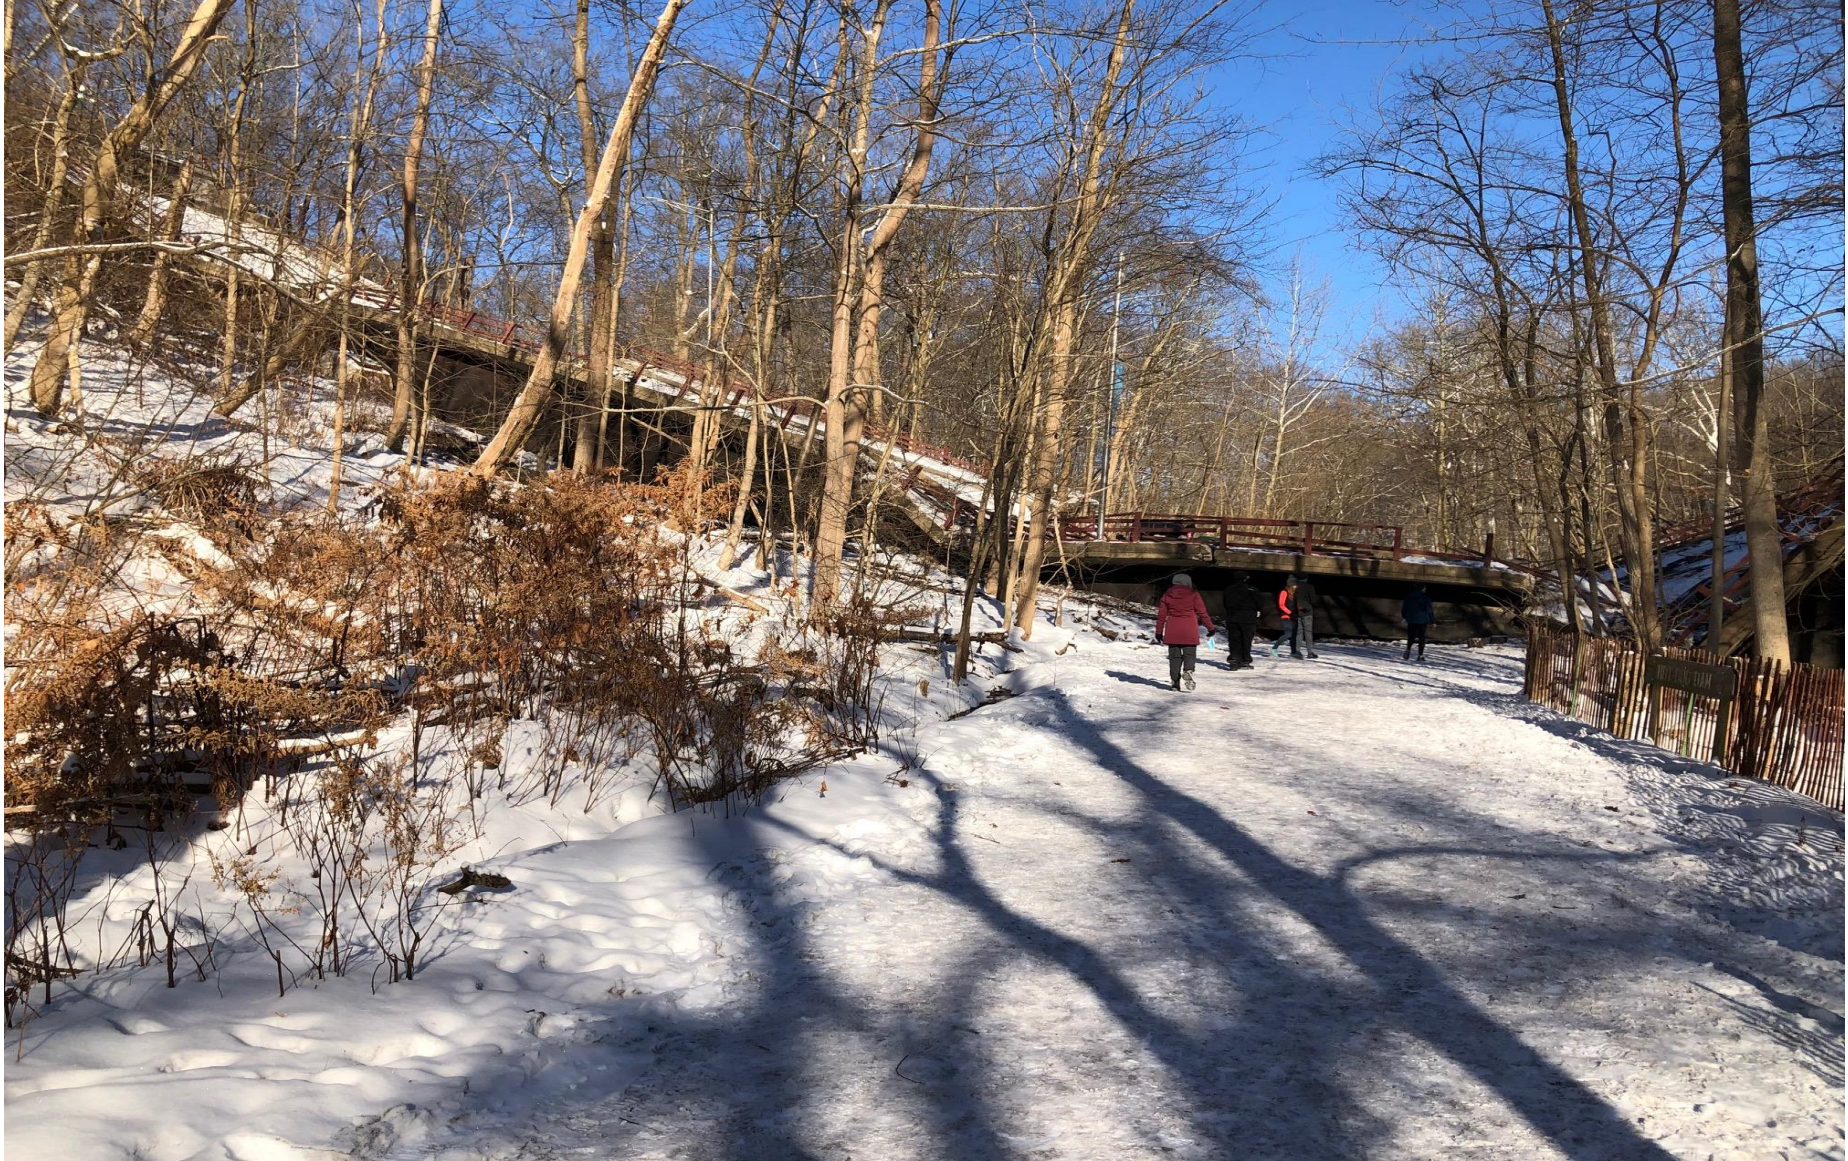
Same Place After – Will Be Used Less

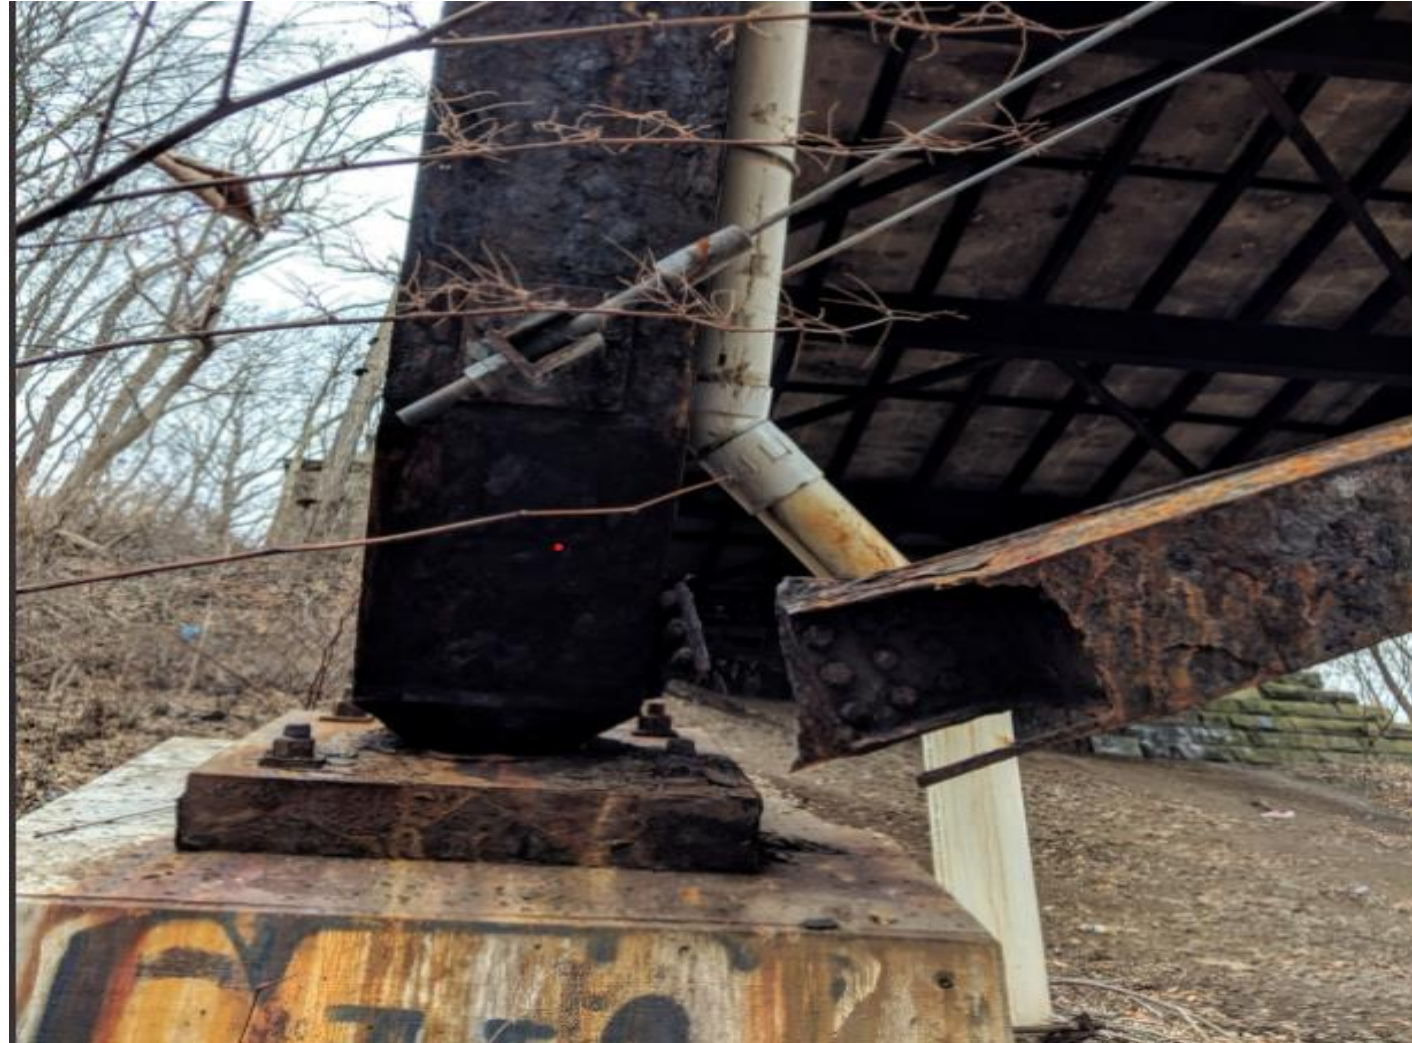
Key Performance Indicator --- Hiker to city - 2018 “I hope someone is keeping an eye on the ... bridge One of the big "X" beams is rusted through entirely (I see the cables, ... probably not a crisis).”

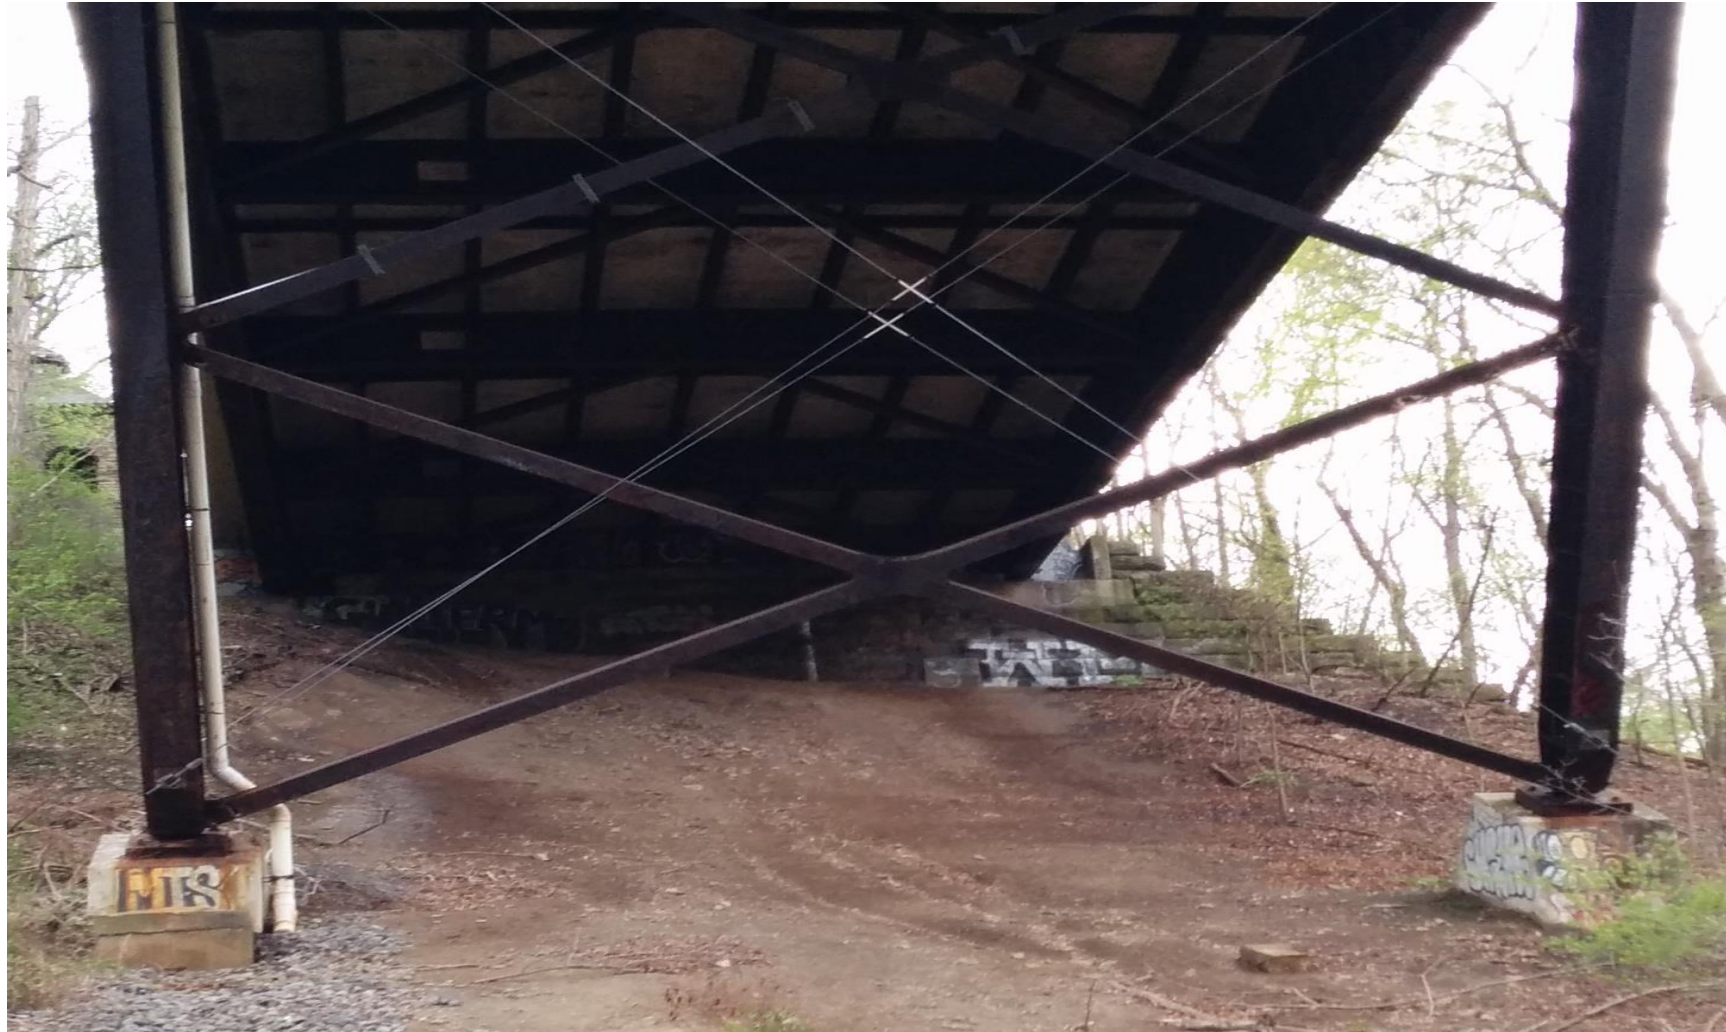
Lower left-hand leg of the X-brace was found detached in 2018 by a hiker; tensioned cables were installed.

- 2014, State requires annual inspection,
- 2018 removed the rusted X shaped bracing from sub structure after citizen report,
- At some point cables were installed,
- City recognized needed repairs, not viewed as “imminent hazards”
- 2013 the cables were found loose and were tightened in 2014,
- Weight limit on the bridge being reduced from 36 tons to **26 tons**,
- Last inspection was September 2021 by international firm.

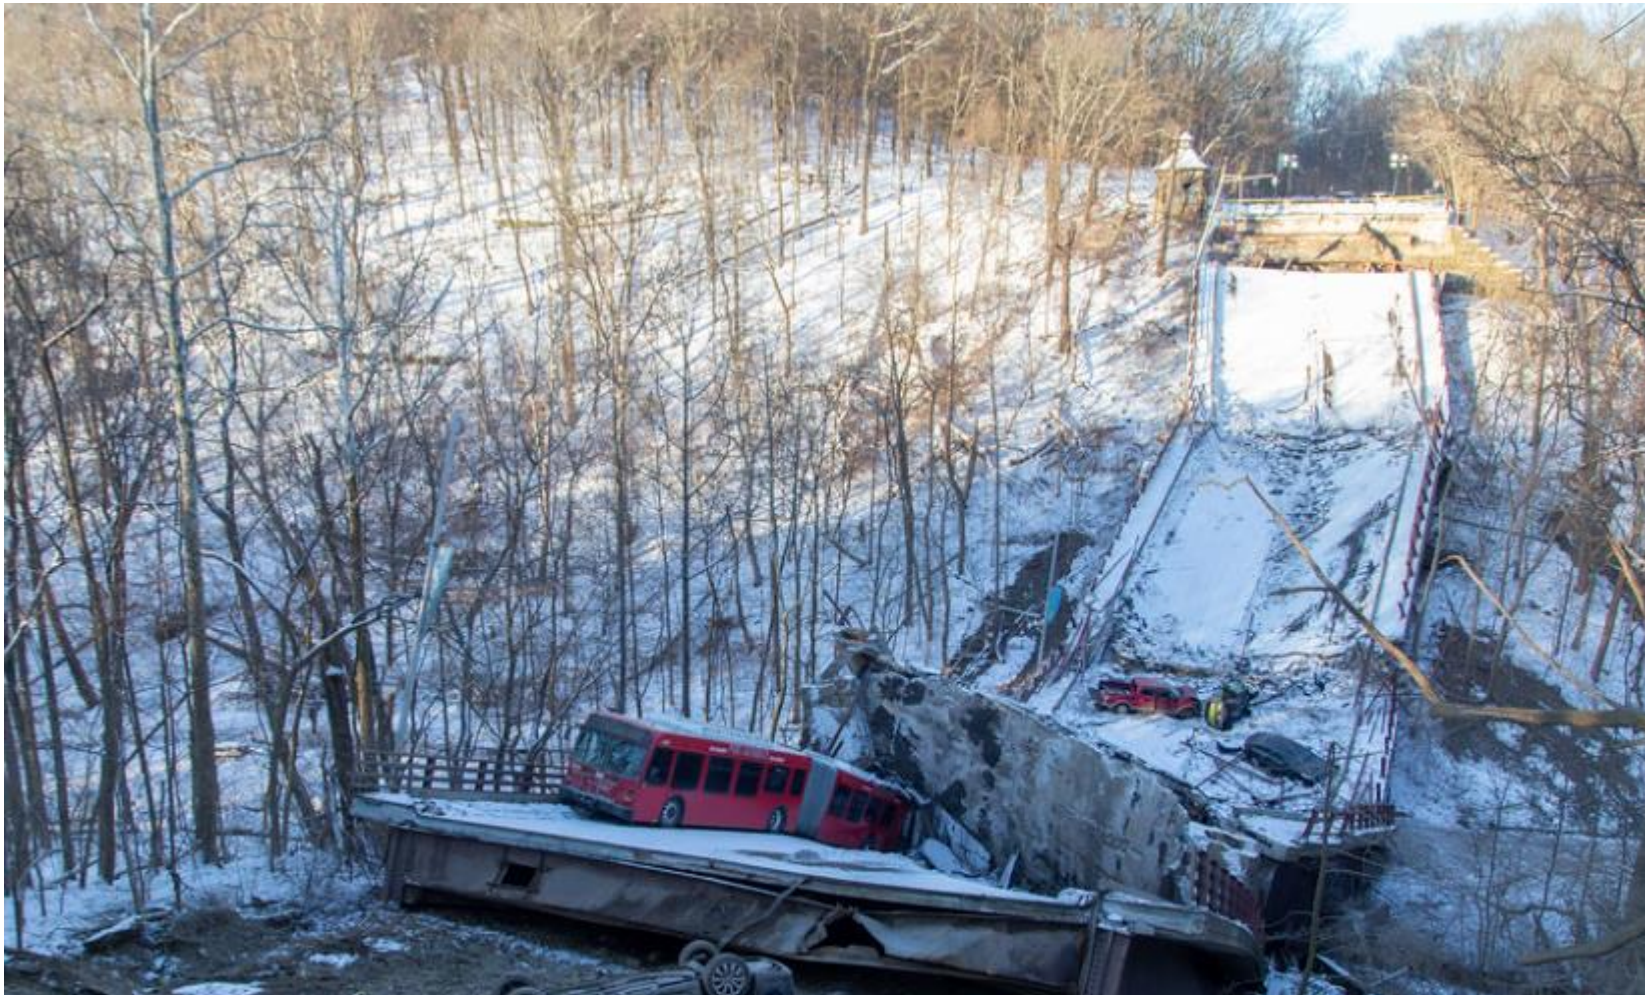
60-foot 21-ton Bus on Collapsed Bridge

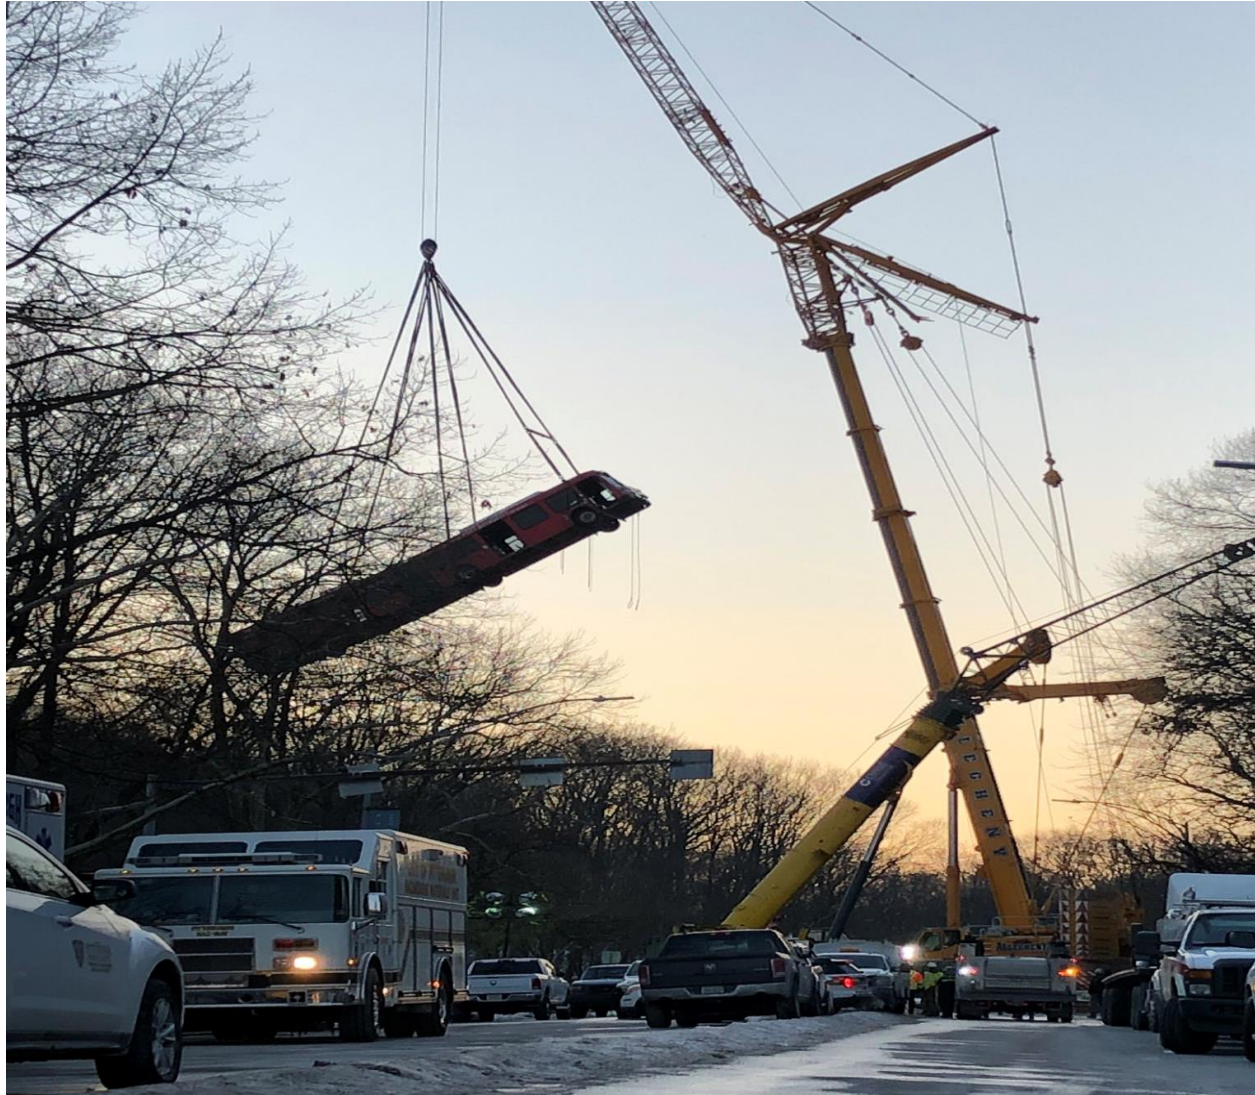
60-foot 21-ton Articulated Bus Removed
